Application No. **09/894,375**

Title: **Method of Coating Smooth
Electroless Nickel on Magnetic
Memory Disks and Related Memory
Devices**

DECLARATION OF INVENTOR UNDER 37 CFR §1.132

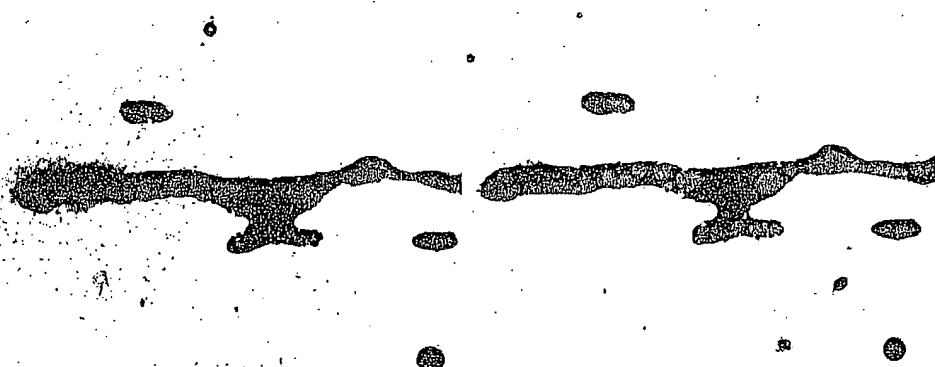
As polished (not etched) 350X As polished (not etched) 350X
 2869, 2870 Comparison of polishing methods for showing inclusions in wrought iron. For micrograph 2869 (left), specimen was polished on 10-to-20-micron alumina on billiard cloth; for micrograph 2870 (right), it was polished on 4-to-8-micron diamond on a synthetic suede cloth. Specimens in both micrographs were abraded on a fixed-abrasive lap before polishing.

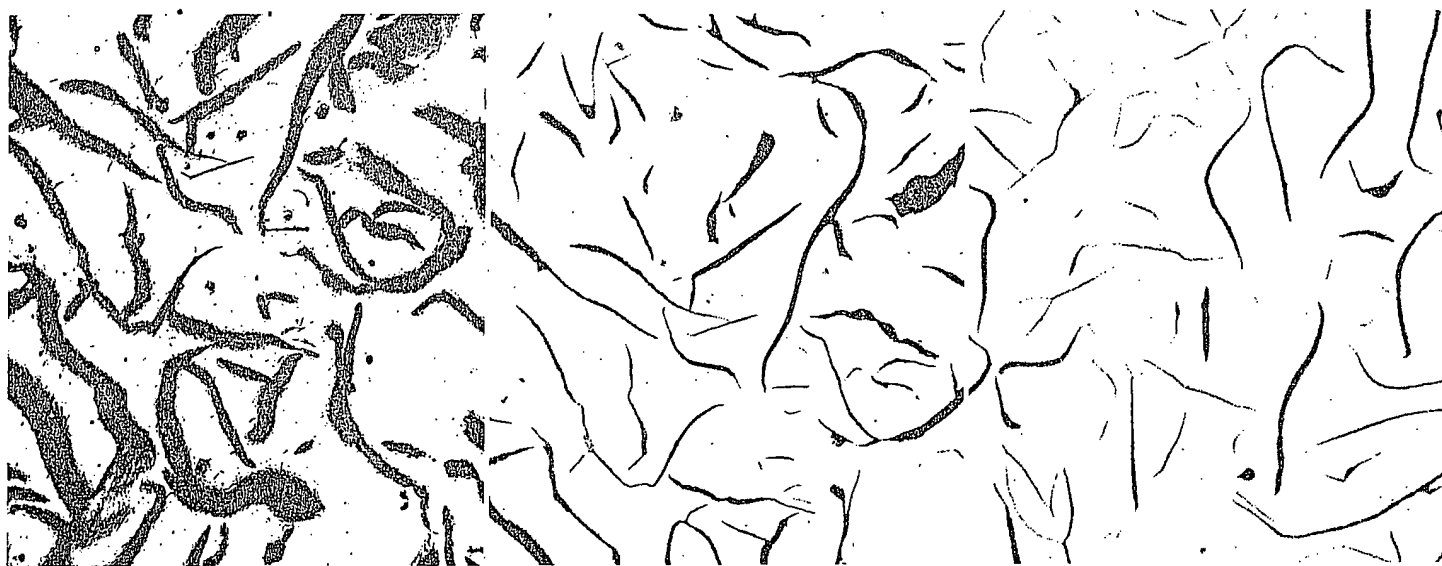
As polished (not etched) 250× As polished (not etched) 250× As polished (not etched) 250×
2873, 2874, 2875 Comparison of polishing methods for retention of graphite in gray iron. Micrograph 2873 (left) shows the results of polishing on 10-to-20-micron alumina on billiard cloth (long nap). Micrograph 2874 (center) shows the results of polishing on 1-micron diamond on synthetic suede cloth (short nap). Micrograph 2875 (right) shows the results of polishing on 1-micron diamond on cotton drill (napless). All specimens were abraded on a fixed-abrasive lap before polishing.

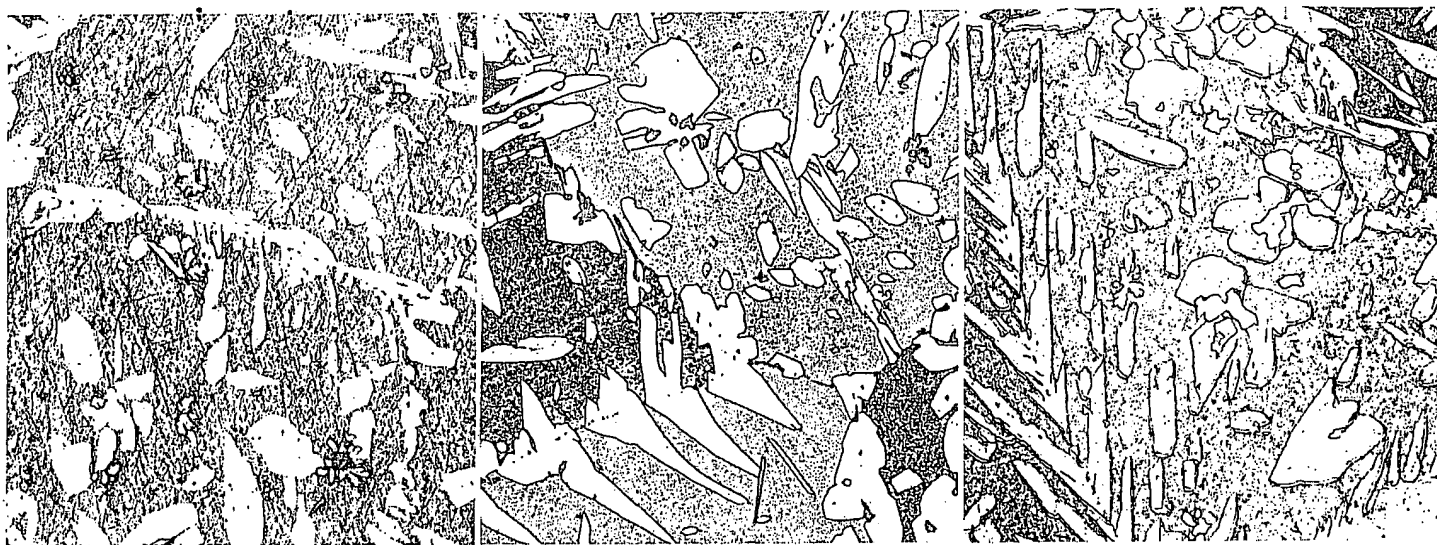
As polished (etched during polishing) 500× As polished (etched during polishing) 500× As polished (etched during polishing) 500×
2888, 2889, 2890 Effect of addition of different amounts of ammonium hydroxide to the suspending liquid in vibratory polishing of a cast alpha-beta brass. Specimens were polished with magnesia suspended in a mixture of three parts propylene glycol, one part water. Micrograph 2888 (left): using no addition of ammonium hydroxide; note numerous polishing scratches. Micrograph 2889 (center): using an optimum addition of ammonium hydroxide. Micrograph 2890 (right): using an excessive addition of ammonium hydroxide; note excessive relief between the two phases.

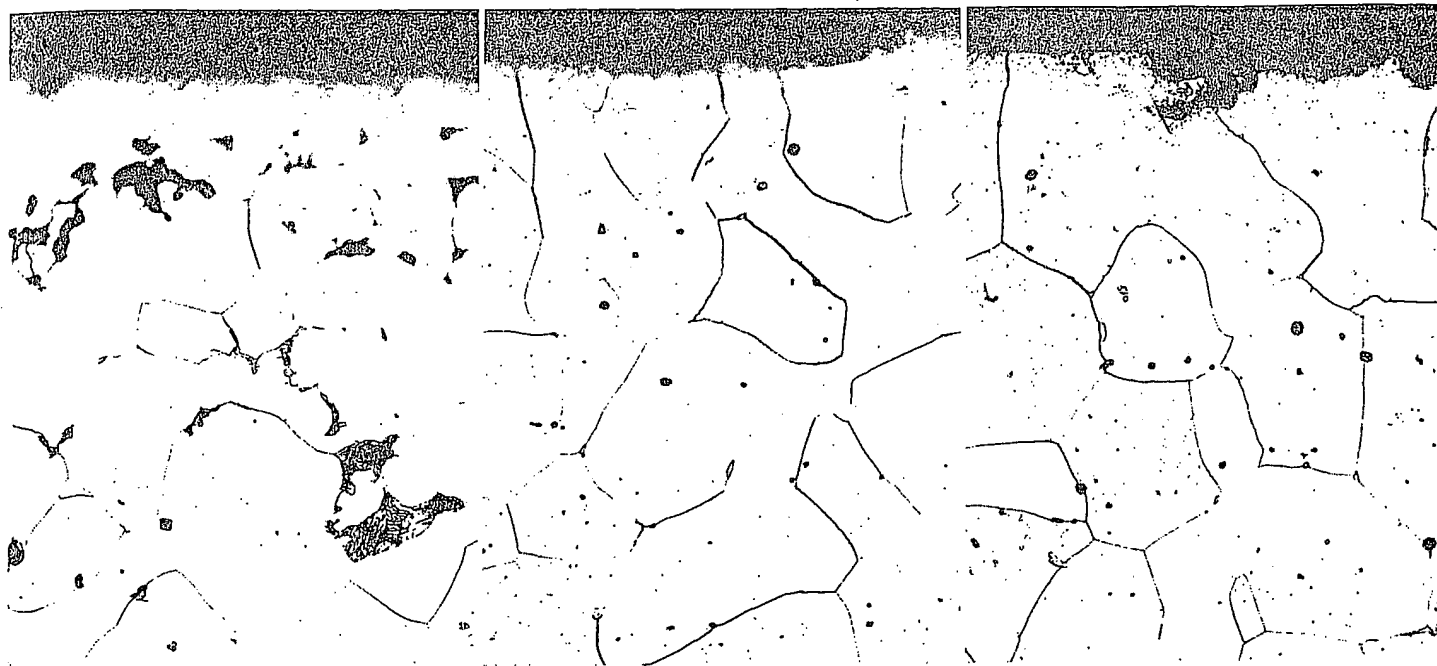
Nital 500X Nital 500X Nital 500X
2893, 2894, 2895 Effect of type of mounting plastic on edge retention of steel specimens polished by standard technique. Micrograph 2893 (left): specimen mounted in a phenolic plastic; also representative of edge retention using an epoxy. Micrograph 2894 (center): specimen mounted in an allyl plastic. Micrograph 2895 (right): specimen mounted in a polyvinyl formal plastic; also representative of edge retention using polyvinyl chloride plastic.

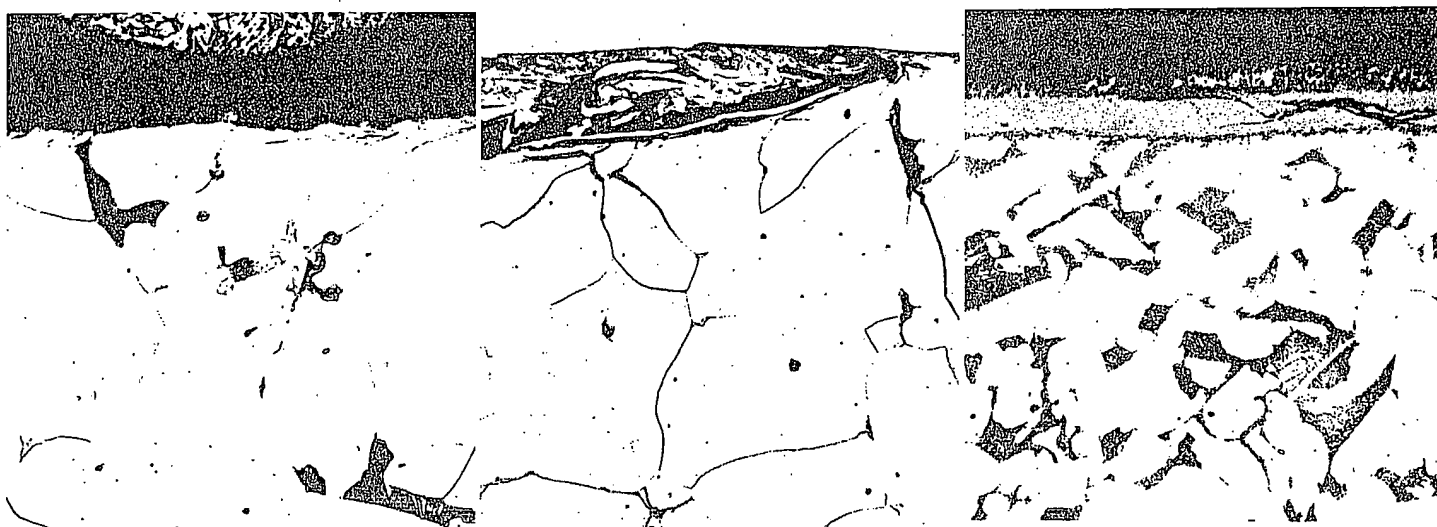
Nital 500X Nital 500X Nital 500X
2896, 2897, 2898 Effect of special techniques for improving edge retention of steel specimens mounted in an epoxy resin. Micrograph 2896 (left): steel shot incorporated in the mount; specimen finish polished by a standard technique. Micrograph 2897 (center): edge protected by an electrodeposited coating of nickel; specimen finish polished by a standard technique. Micrograph 2898 (right): specimen finish polished using a fairly rigid napless pad and diamond abrasive.
